Natural fire tests in a dormitory with fire protected furniture

Abstract

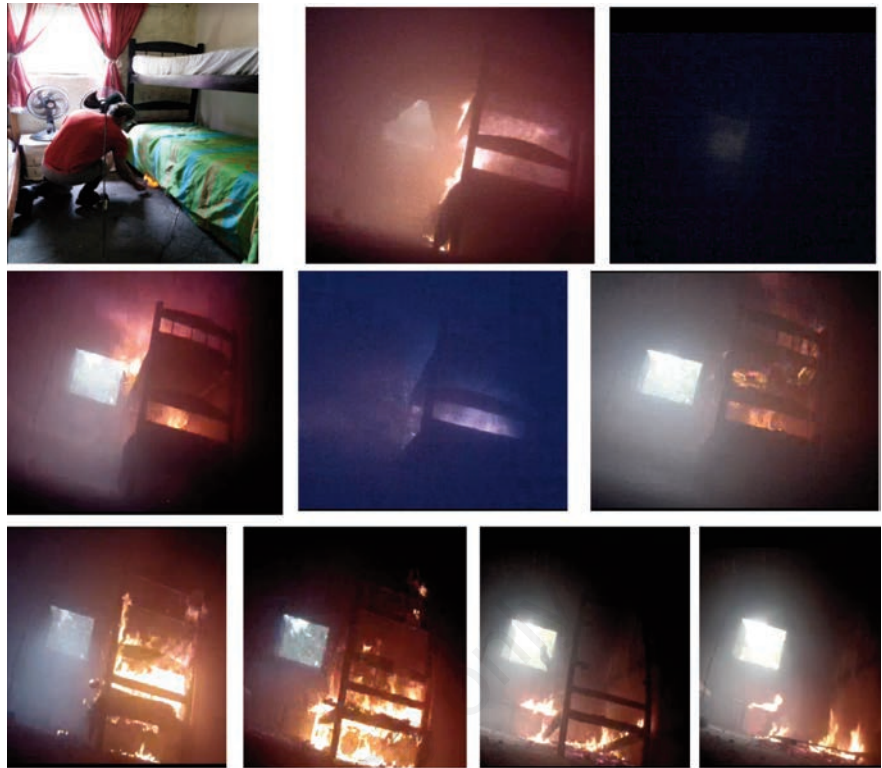
Figure 2. Timeline of the experiment. Reproduced with permission from Corrêa *et al.*⁷

The basic chronology, as evidenced by Corrêa *et al.*,¹⁰ is shown below and details the events of the experiment itself: i) 00min35sec - Fire was started using the paraffin device; ii) 03min56sec - Start to ignite the upper mattress of the bunk bed; iii) 06min22sec - Saturation of combustion gases; iv) 07min38sec - End of the saturation by natural exhaust of the gases and air intake with return of the flames; v) 10min36sec - New Saturation of combustion gases; vi) 11min49sec - End of the second saturation by natural exhaust of the gases and air intake with return of the flames; vii) 18min02sec - Opening doors allowing cross air circulation; viii) 19min04sec - fire propagation to a different material; ix) 21min29sec - The plastic fan

over the nightstand start to ignite; x) 41min43sec - Total collapsed of the bunk bed (Figure 2). The entire experiment was measured using temperature-transmitting thermocouples connected to a National Instruments CompactDAQ USB module, with an NI 9213 measuring tool having a sensitivity of 0.02°C. It should be noted that the uncertainty of the thermocouple is approximately 2.2°C for temperatures below 293°C, and +/- 0.75% for higher temperatures (OMEGA, 2004).¹¹ An example of this data can be seen in Figure 3 below.

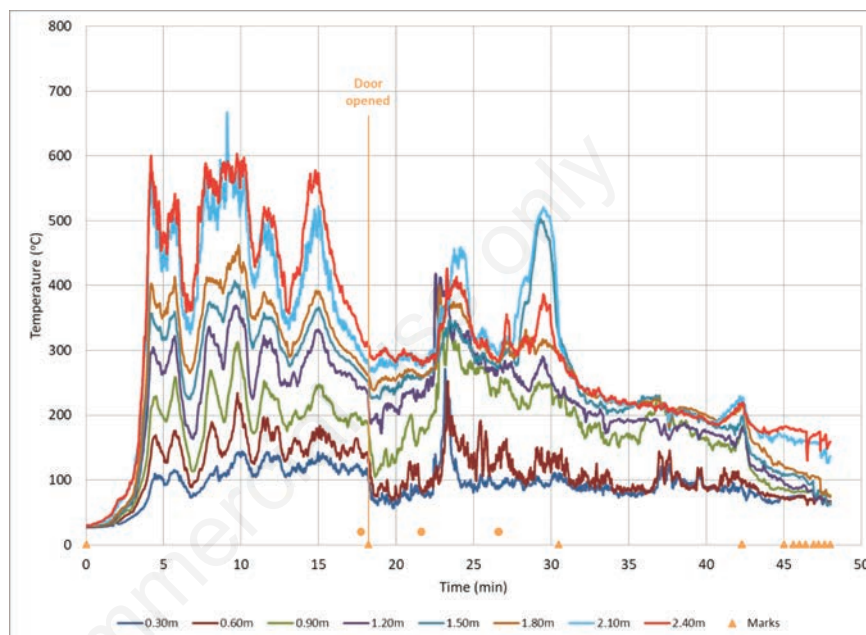
Figure 3. Temperature at different heights at the center of the bedroom. Reproduced with permission from Corrêa *et al.*⁷

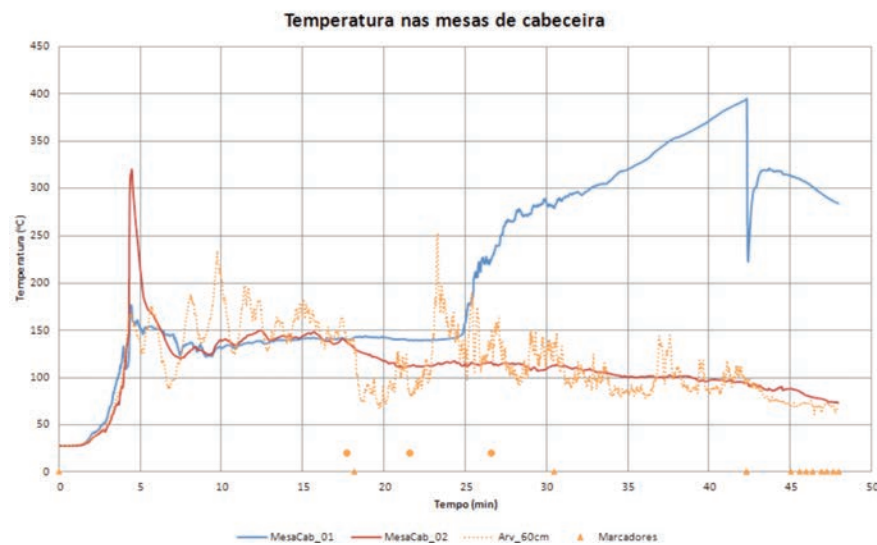
Figure 4. Temperature reached by the bedside tables during the event.

By analyzing the time lag between the occurrence of events and comparing it with the graph in Figure 4, important relationships between the furniture with intumescent paint and the environment are observed. Comparing the behavioral characteristics indicated in the chart, which deals specifically with the bedside tables, will provide a more accurate observation of what happened.

In Figure 4, three lines are seen, which represent the temperatures of the furniture tested and the environment. The blue and red lines represent, respectively, the thermocouples installed on the untreated bedside table and on the table with intumescent paint. The orange dotted line represents the temperature recorded by the thermocouple at a height of 60 cm, the same height as the upper outer face of the furniture.

It can be seen that during the initial five minutes, the untreated bedside table reached a temperature as much as two times that of the treated table. This is possibly due to the fact that, according to the CKC 268 technical data sheet, after application of the product and when exposed to fire, the paint will be activated by heat, causing the protective

With the reduction in temperature, following the initial five minutes, the ambient temperature at 60 cm remained between 100°C and 250°C until the 18-minute mark. In this same time span, the temperature of the treated furniture varied minimally, maintaining an almost continuous line, while the non-treated furniture showed a higher degree of variation over the same time interval. It is important to note that the treated bedside table was nearer to the bunk where the flame was ignited, as shown in the image.

As the test approached 23 minutes, the air column, along with the gradual destruction of the bunk, causes the flames to be concentrated near the treated bedside table. The partially destroyed bunk had burning fragments in direct contact with the furniture. Thus, the intake of air that initially caused a decrease in temperature provided, over time, oxygen for the flames and allowed the fire to come back to life.¹⁴ The furniture on which the intumescent paint was applied increased in temperature to almost 400°C until the 43-minute mark of the test, when the team of fire fighters entered the room to quench the flames. The bedside table without intumescent paint maintained a temperature of around 100°C until the same 43-minute point.

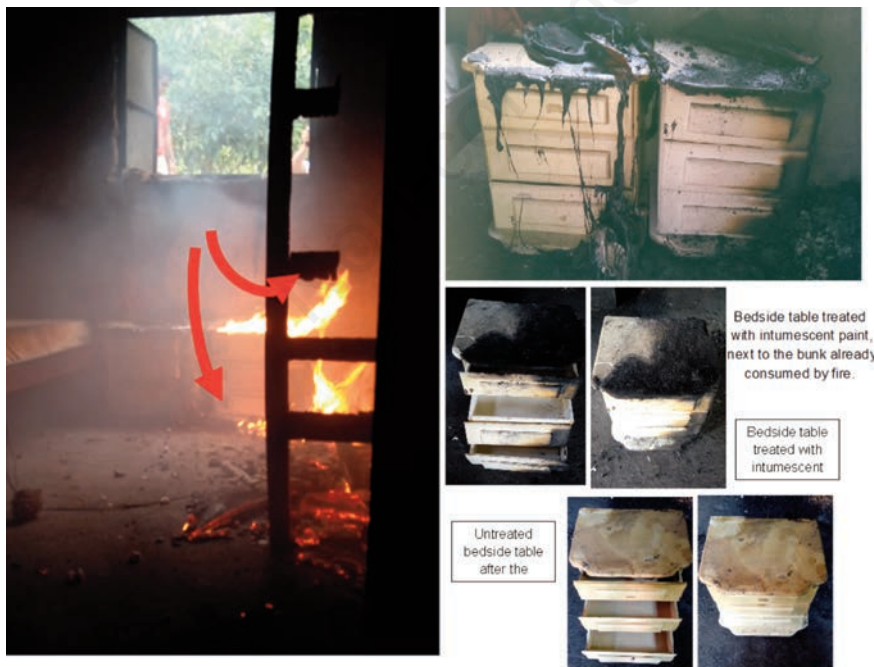
Figure 5. Air column formed between the window and the door, keeping the flames to one side.

After the 18-minute mark of the test, the ambient temperature declined due to the opening of the door by the monitoring team, allowing air to pass between the window and the door and creating cross-ventilation.¹⁴ From that point on, the formation of a column of air passing through the room formed a barrier that prevented the propagation of the flames by irradiation to the furniture located on the opposite side of the dormitory.

The test dormitory was then opened for the study team to enter and verify the damage that occurred, finding the two bedside tables in the following condition (Figure 5).
